ADDENDUM 1
to the
BIDDING DOCUMENTS
for

**Jim Whelan Boardwalk Hall
Boardwalk Façade Renovation – Pilot Project
Atlantic City, MJ**

October 25, 2019

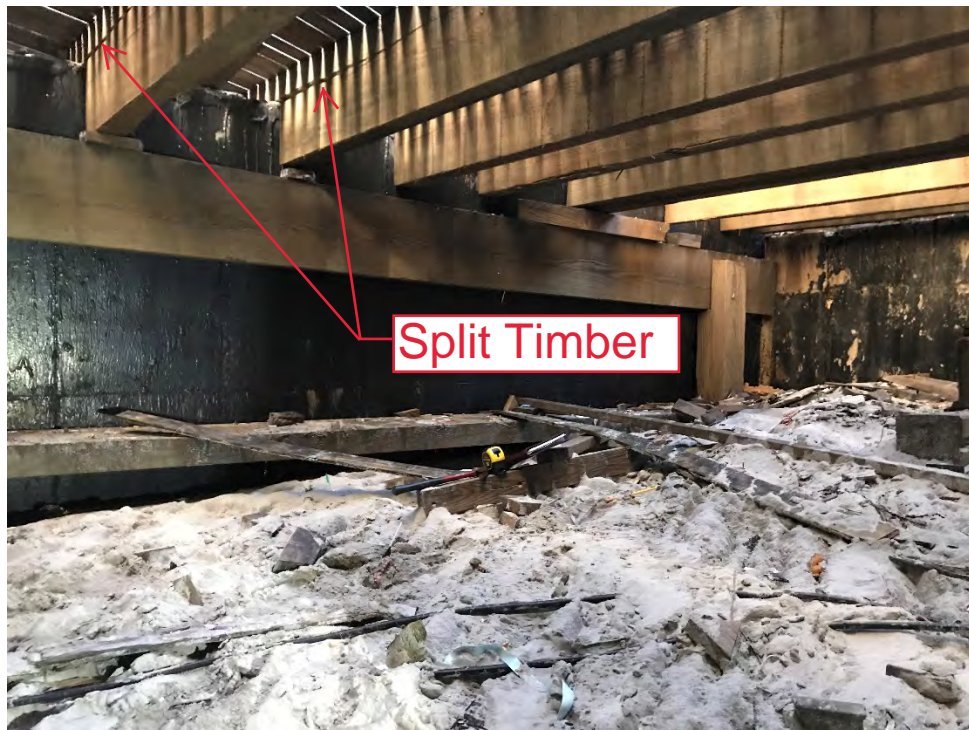
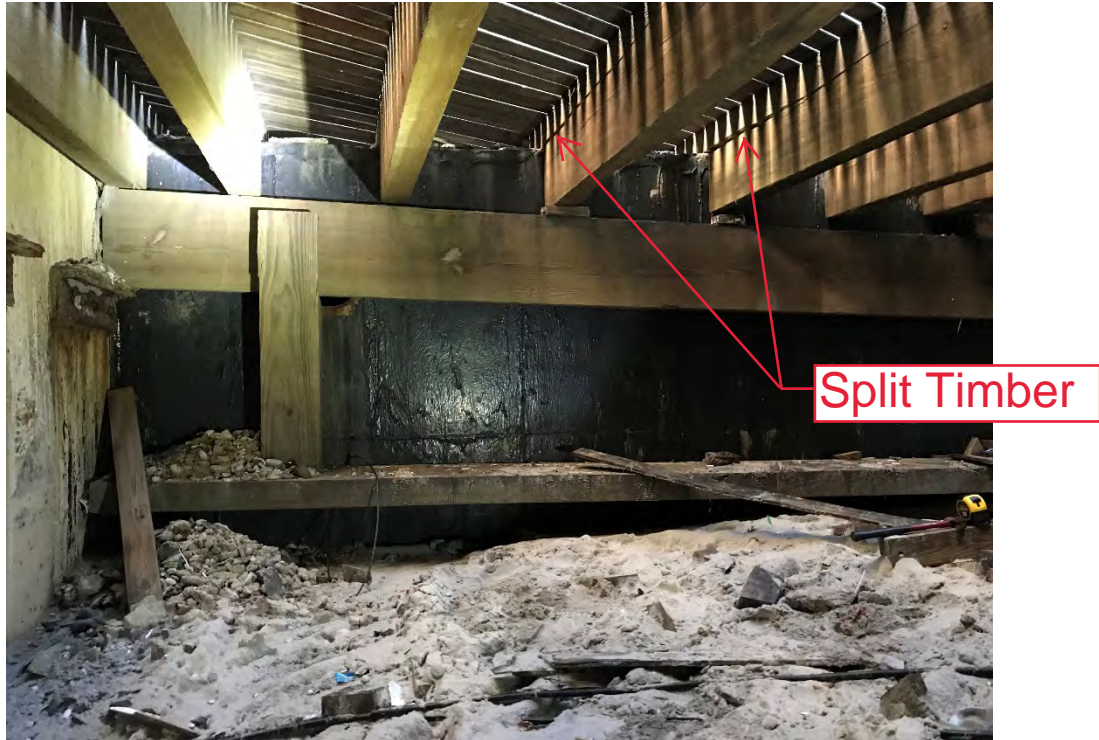
The timber joists supporting the boardwalk deck boards are damaged to the extent that a repair is needed before using any portion of the damaged span during the inspection operation. This damage is visible in the following 2 photographs:

Based on information provided to us regarding the repairs for the area of deterioration, we believe that the repairs are sufficient to hold the original design loads. The steps presented below are illustrated in the following photographs as well:

1. Drilled holes from top to bottom of every split beam.
2. Installed galvanized bolts and nuts through entire beam.
3. Installed anchor bolts through header beam into concrete wall.
4. Shored up the bottom beam.
5. Shimmed all beams/joists as needed.

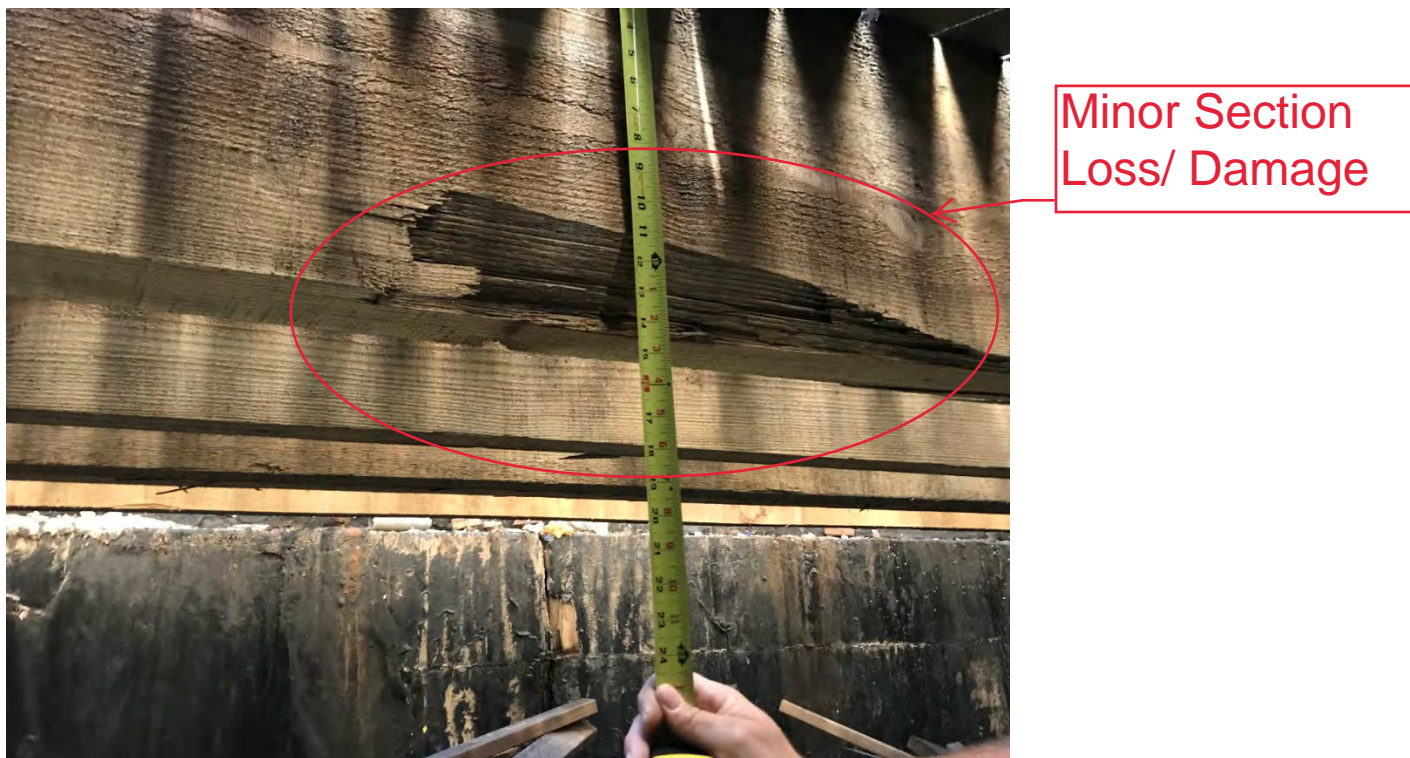
The only other area of concern from the underside inspection is shown in the following photograph:

This damage has only a minor effect on the structural capacity of the joists and is not as critical as the maximum moment capacity at midspan. It is an isolated joist and the damage occurs approximately 4 feet away from the support in a 13'-2" span. The reason this is not important is that the live load

bending moment at this location is only about 85% of the midspan moment and, therefore, the overall stresses are less than those at midspan.

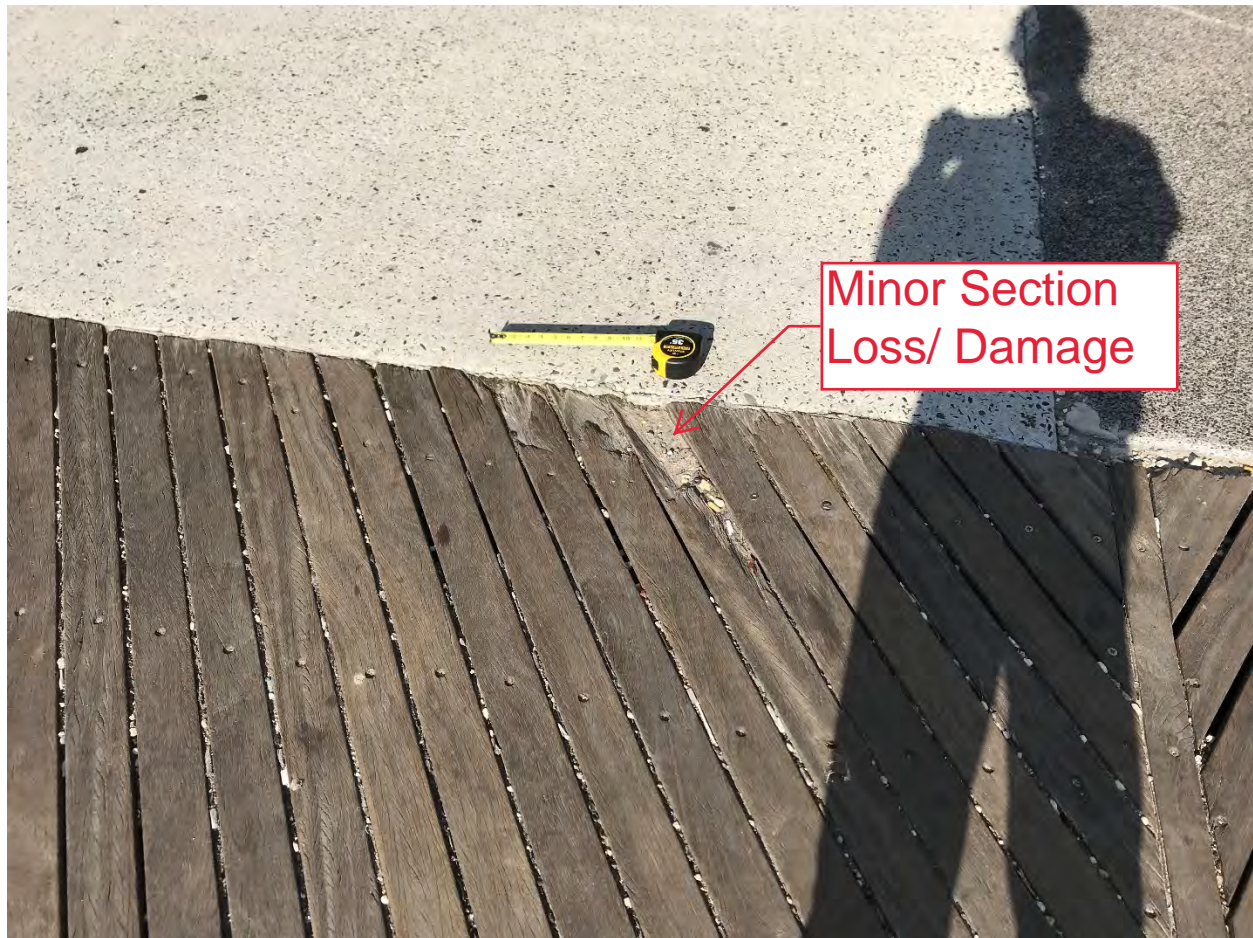
The most significant damage to the top surface of the timber decking is near the edge of the boardwalk as it transitions onto the concrete pavement at the access point to S. Mississippi Avenue, as shown in the following photograph:

The inspection of the top side of the Boardwalk indicates that the timbers are in fair to good condition. As long as the contractor protects the boards from damage using planks and timber mats between the manlift surfaces and the top surface of the boardwalk, we do not anticipate any problems during the façade inspection operations. One cautionary note is that not all of the timbers were visible from below (for instance those above the concrete tunnels were not exposed). These may have some deterioration, but the equipment should not have any issues associated with a subsequent deflection for these timber boards.

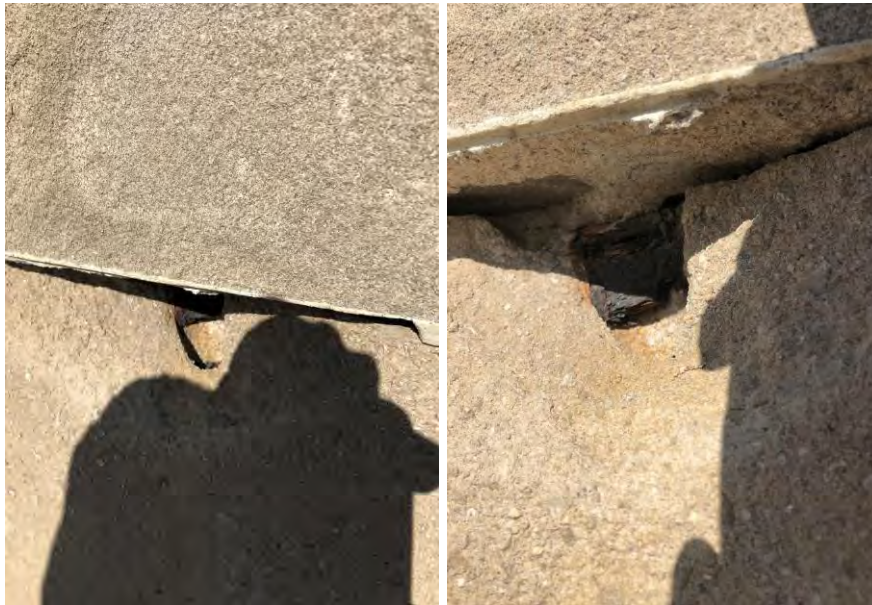
For a building of this construction period (1929) and design, it is common to use Lewis or Lifting holes (holes drilled into the top of stones to help hoist them in place during construction) to embed anchors. This has been confirmed in places, such as in Area 5 where a corroded anchor has spalled the surrounding stone revealing its position in a Lewis hole (See Figure 4 below); however this is not always the design as numerous scanned stones contained empty Lewis holes and also adjacent anchors, presumably chased directly into the top of the stone.

Fig 4: Left: Corroded anchor set in Lewis (Lifting hole) / **Right:** Close up view of corroded anchor

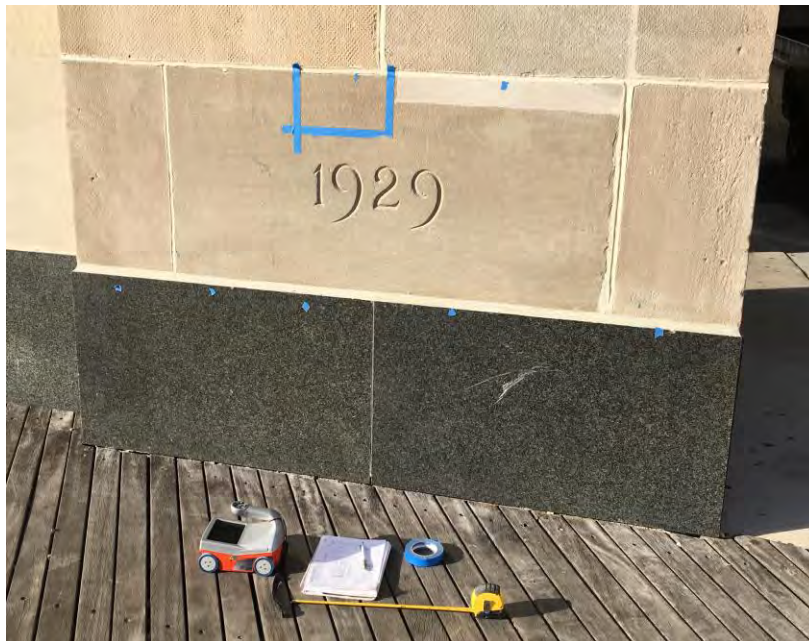
The 'box' is assumed to be a time capsule and was an unexpected find during this investigation (See also Appendix, Drawing D02, Figures 2C and 2D)

Fig 5: NDE equipment identified embedded metal box thought to be a time capsule in the corner stone

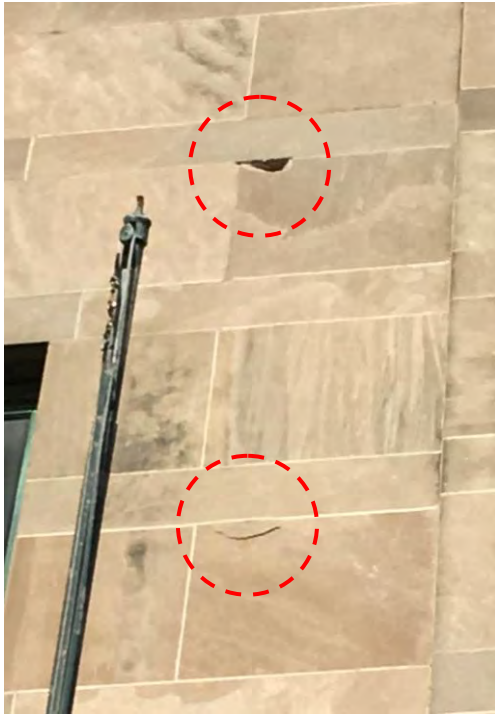
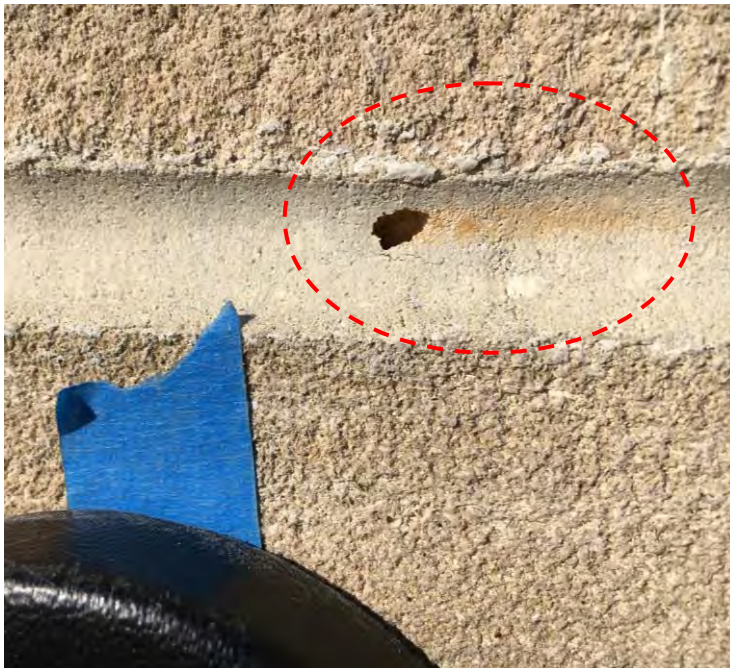
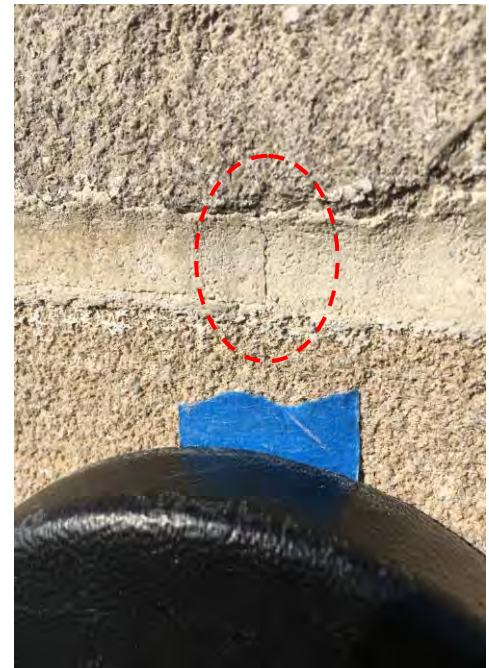
Note: In some cases corrosion of anchors will also be due to poorly pointed mortar joints between stones and not always shallow embedment depth.

Fig 6:

Top Left: Spalled stone (top) and spalling stone (bottom) due to anchor corrosion

Bottom Right: Close inspection of mortar joint reveals Hairline cracking through mortar joint at near surface embedded anchor

Note: Spalling and cracking associated with corroding anchors is more significant at the upper levels due to increased exposure to wind driven rain conditions.

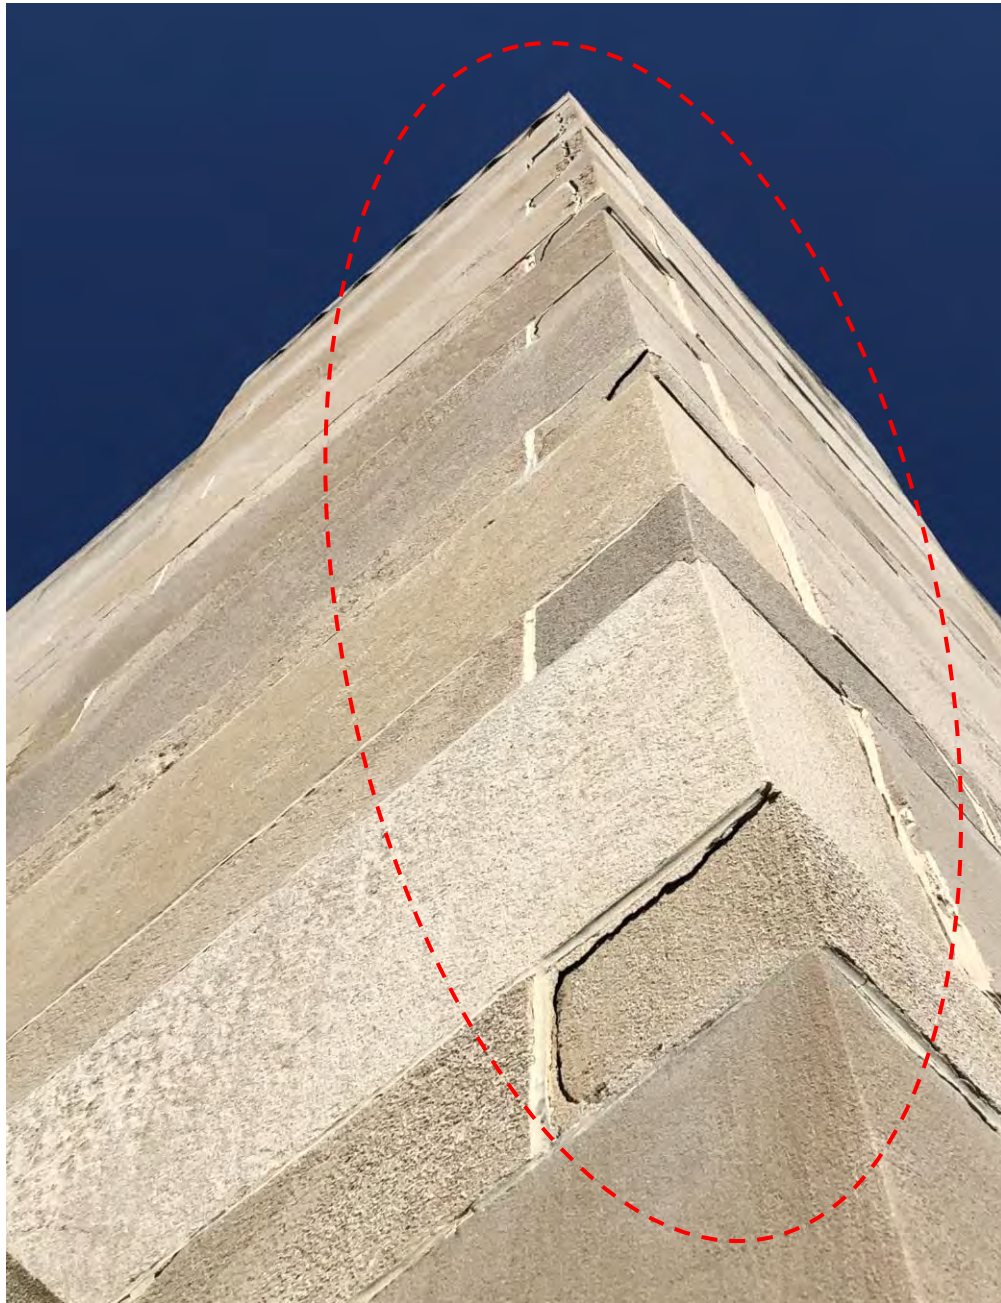
Note: Columns identified at Areas 4 and 5 have damaged the stonework mainly at the corners of elevations and not between windows. This is likely due to the detailing, which may leave columns between protected at the central spans.

Fig 7: Significant stone displacement and cracking at the corners (especially at high level) associated with corroding embedded columns

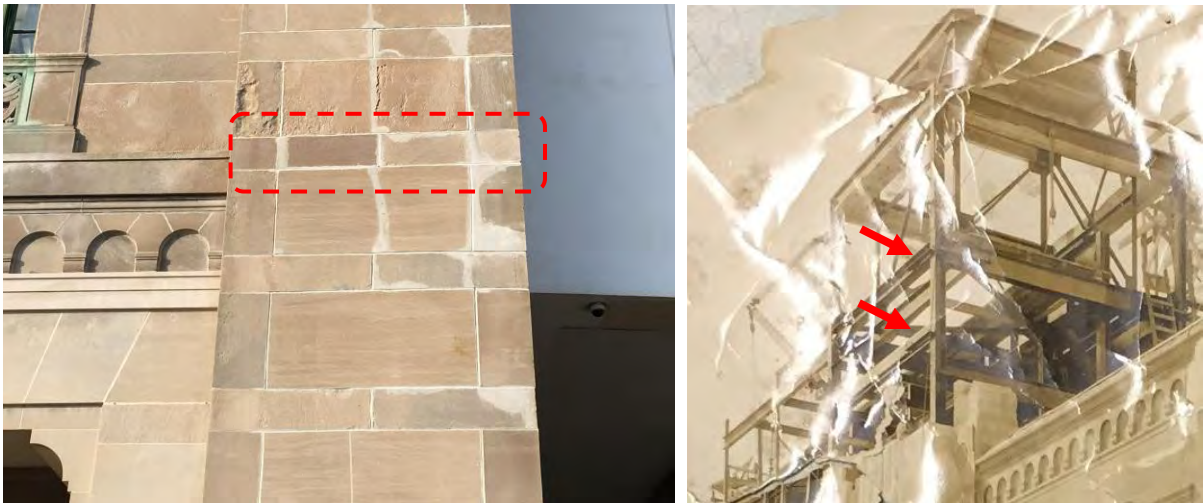
It should also be noted that between Visit 1 and 2, PFA located a historic photograph of the building during construction. The photograph confirmed the existence of the shelf angles which (in the exposed upper section of the Pylon) are welded or bolted to spandrel beams behind (See also Fig 8 below - right).

Fig 8: Left: Significant repairs and also cracking through thinner stone course below the shelf angle confirms active corrosion to the steel (See also Appendix Figure 2 for likely angle position in stone) / **Right:** Historic construction photograph (provided by PFA) revealing existence of shelf angles attached to spandrel beams

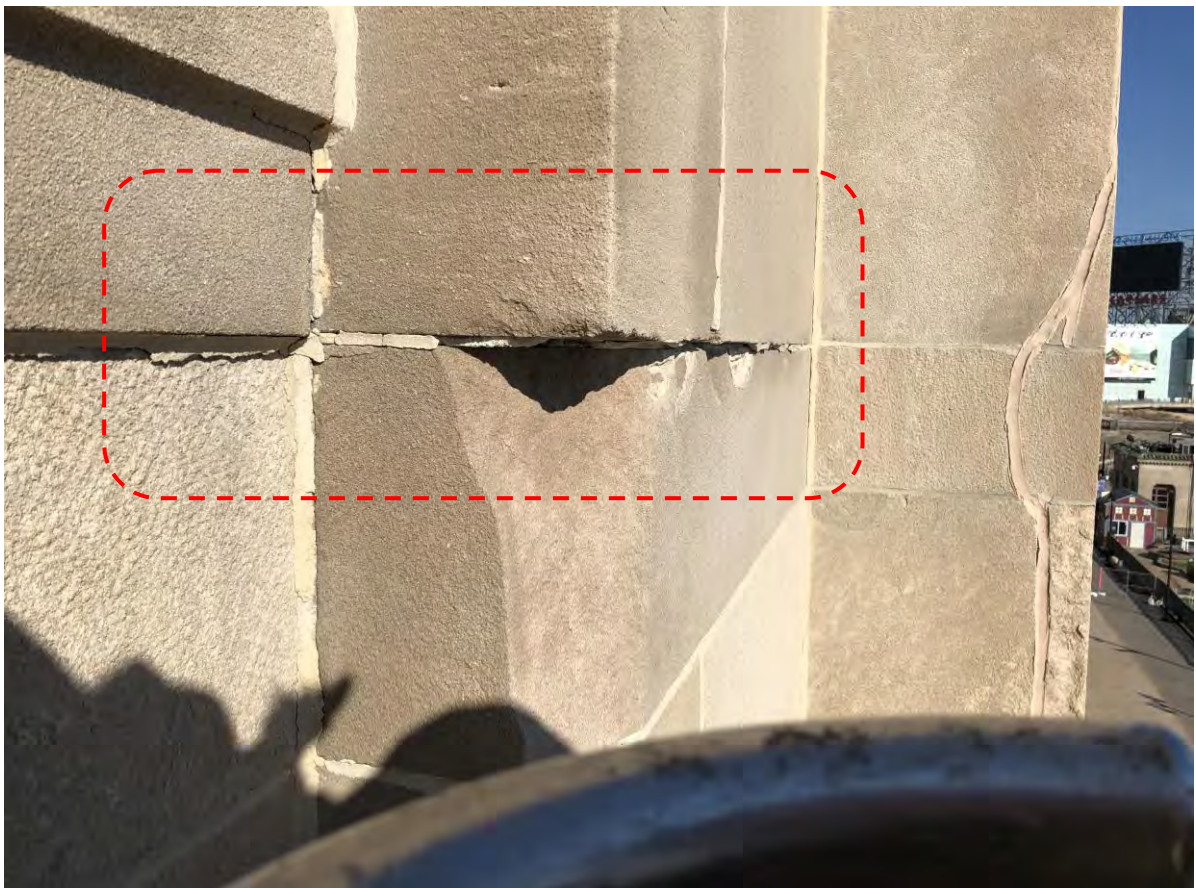
Note: As the spandrel beams are positioned behind the stone and appear to be embedded in combinations of terra cotta tile and brick masonry back up they are reasonably well protected from wind driven rain. As a result, damage to the stone from corroding spandrels appears relatively minor and any damage that has occurred appears to be limited to connections and corners (See Figure 9 below).

Fig 9: Area 5: Significant cracking, open jointing and stone movement occurring at corner, likely as a result of spandrel beam and column corrosion behind pier

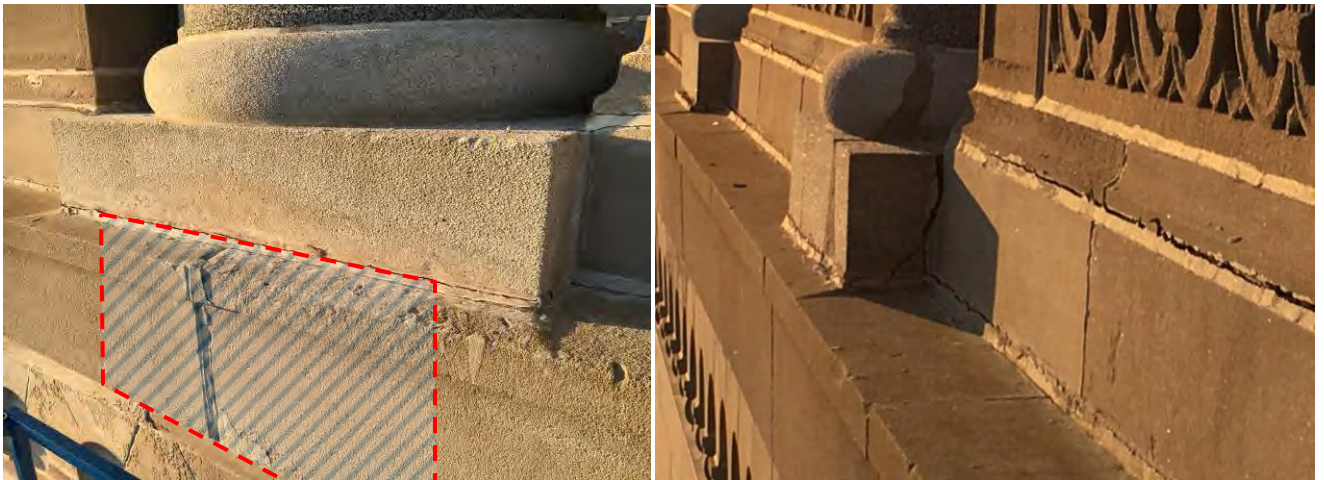
The plinth however, containing metal (steel 'I' sections or reinforced concrete or similar) are coincident with significant displacement to the surrounding stone, beneath each column and suggests that expansive corrosion of the embedded steel is actively pushing out the stone, causing bulging of the stone course that extends horizontally from each column (See Figure 10 below).

Fig 10: Cracking and pushing out / displacement of stone in front of and extending away from the Loggia stone column locations is indicative of active expansive corrosion to embedded metalwork in plinth (Area hatched blue highlights the approximate extent of stone containing steel – embedment depth 5")

In order to fully appreciate the extent of corrosion to the embedded steel beneath the columns, targeted exposures through the stone will be necessary.

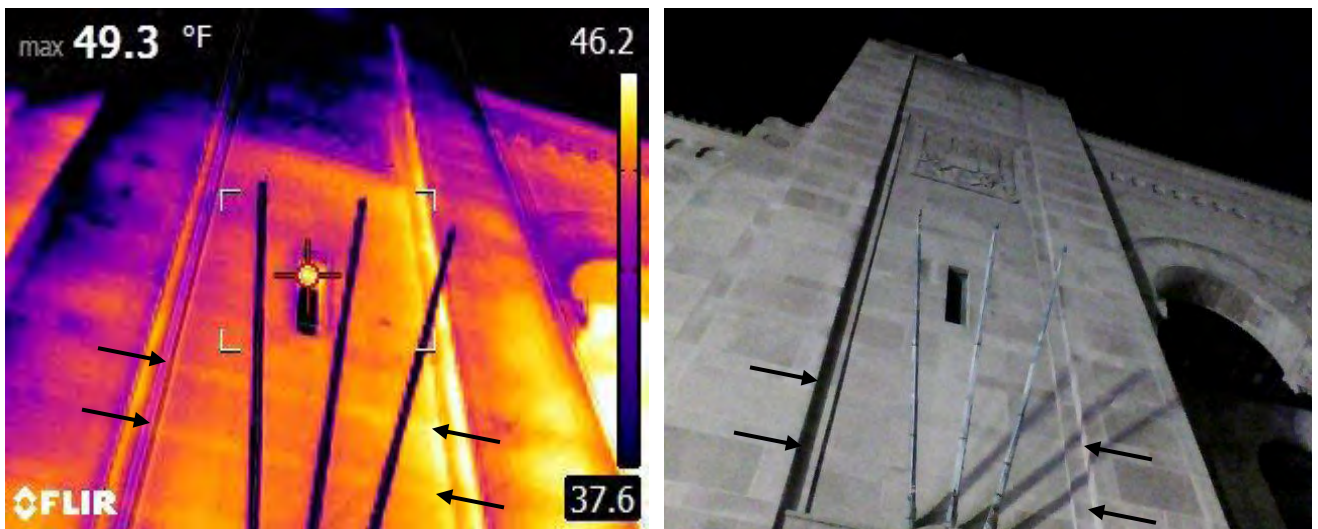
Note: Thermal images confirmed results from the detailed survey areas that confirm that block courses of alternating thicknesses exist across all elevations.

Fig 11: Horizontal hotter (lighter) stone courses highlight thicker stones as a result of increased heat retention

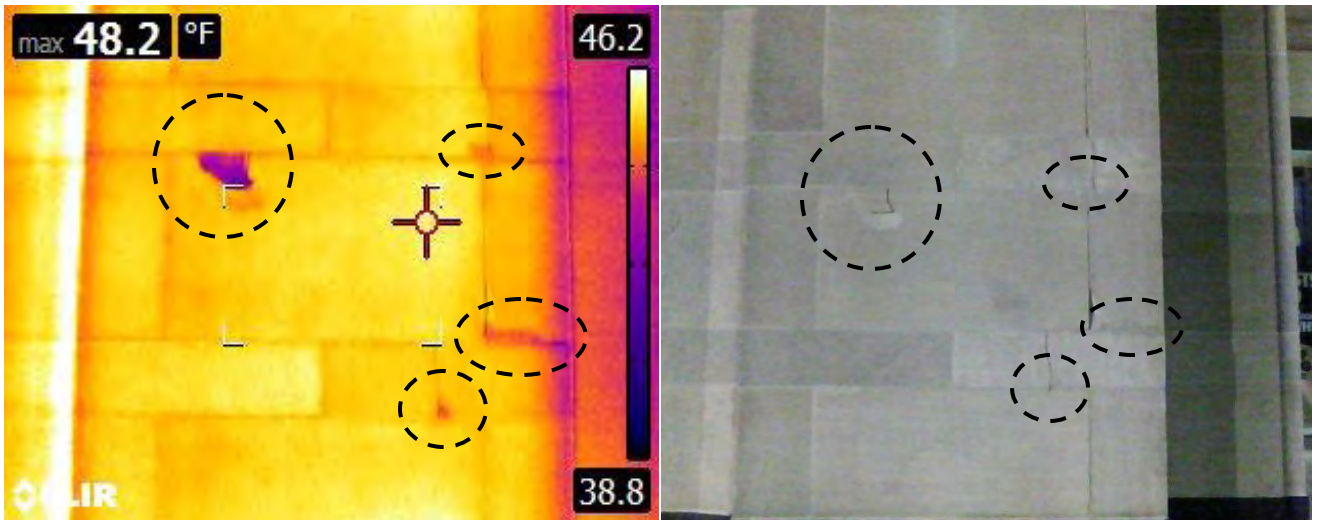
Assessment of the surface temperature is able to provide information regarding stone spalling. As this assessment was conducted at the end of the day and in cold conditions thinner sections of stone cooled more rapidly than the larger mass of the stone blocks they were detaching from; therefore they provided localized cooler responses (See Figure 12 on the following page).

Fig 12: Localized cooler (darker) responses highlight areas of spalling stone, already detaching from the façade

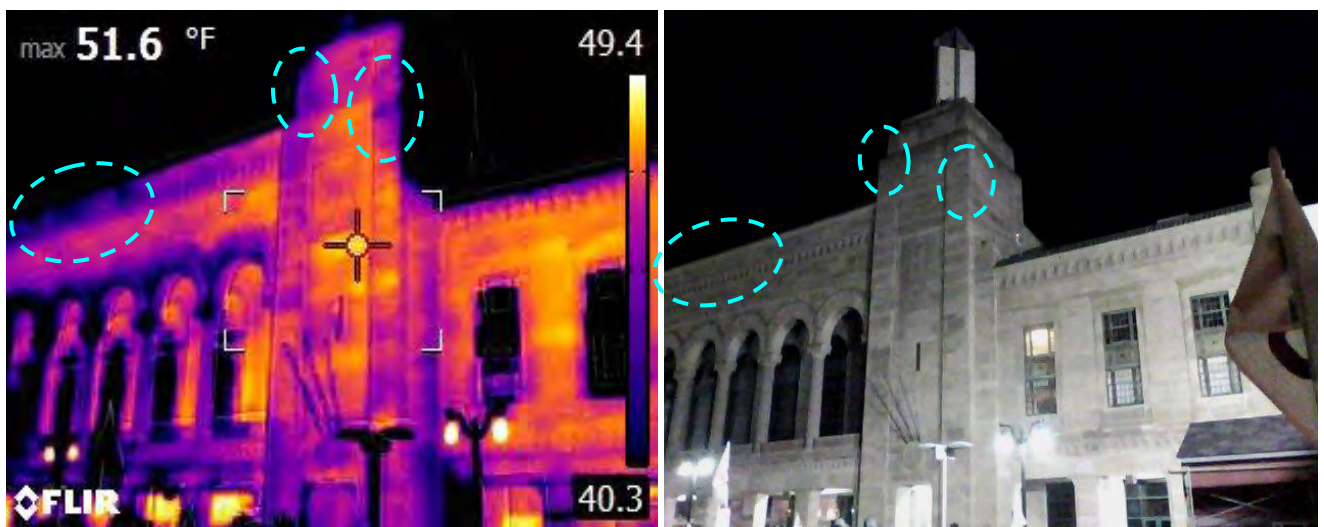
Moisture close to the surface is typically mapped as a cooler response, which can be further verified through the use of a moisture meter (See Figure 13 below).

Fig 13: Cooler (darker) responses in thermal images can highlight areas of moisture retention and open jointing / stone displacement due to increased flow of cool air through mortar joints.

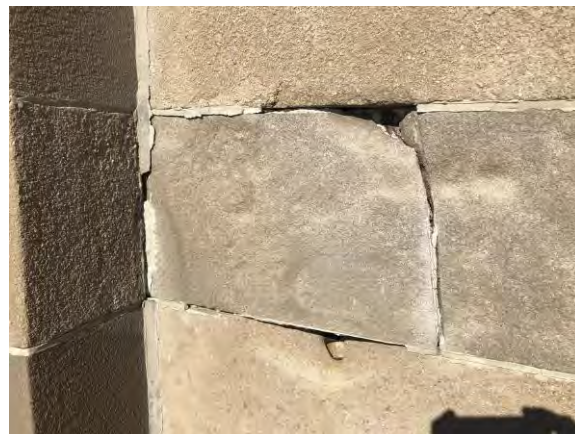
FIGURE 5C: SIGNIFICANT DAMAGE TO STONE IN FRONT OF SPANDREL BEAM

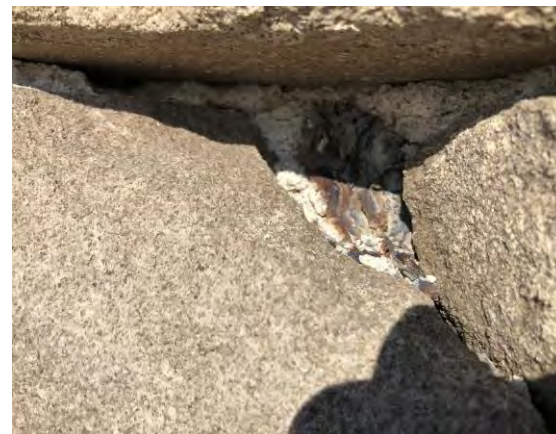
FIGURE 5D: CLOSE UP OF CORRODED ANCHOR – COVER DEPTH 1½"

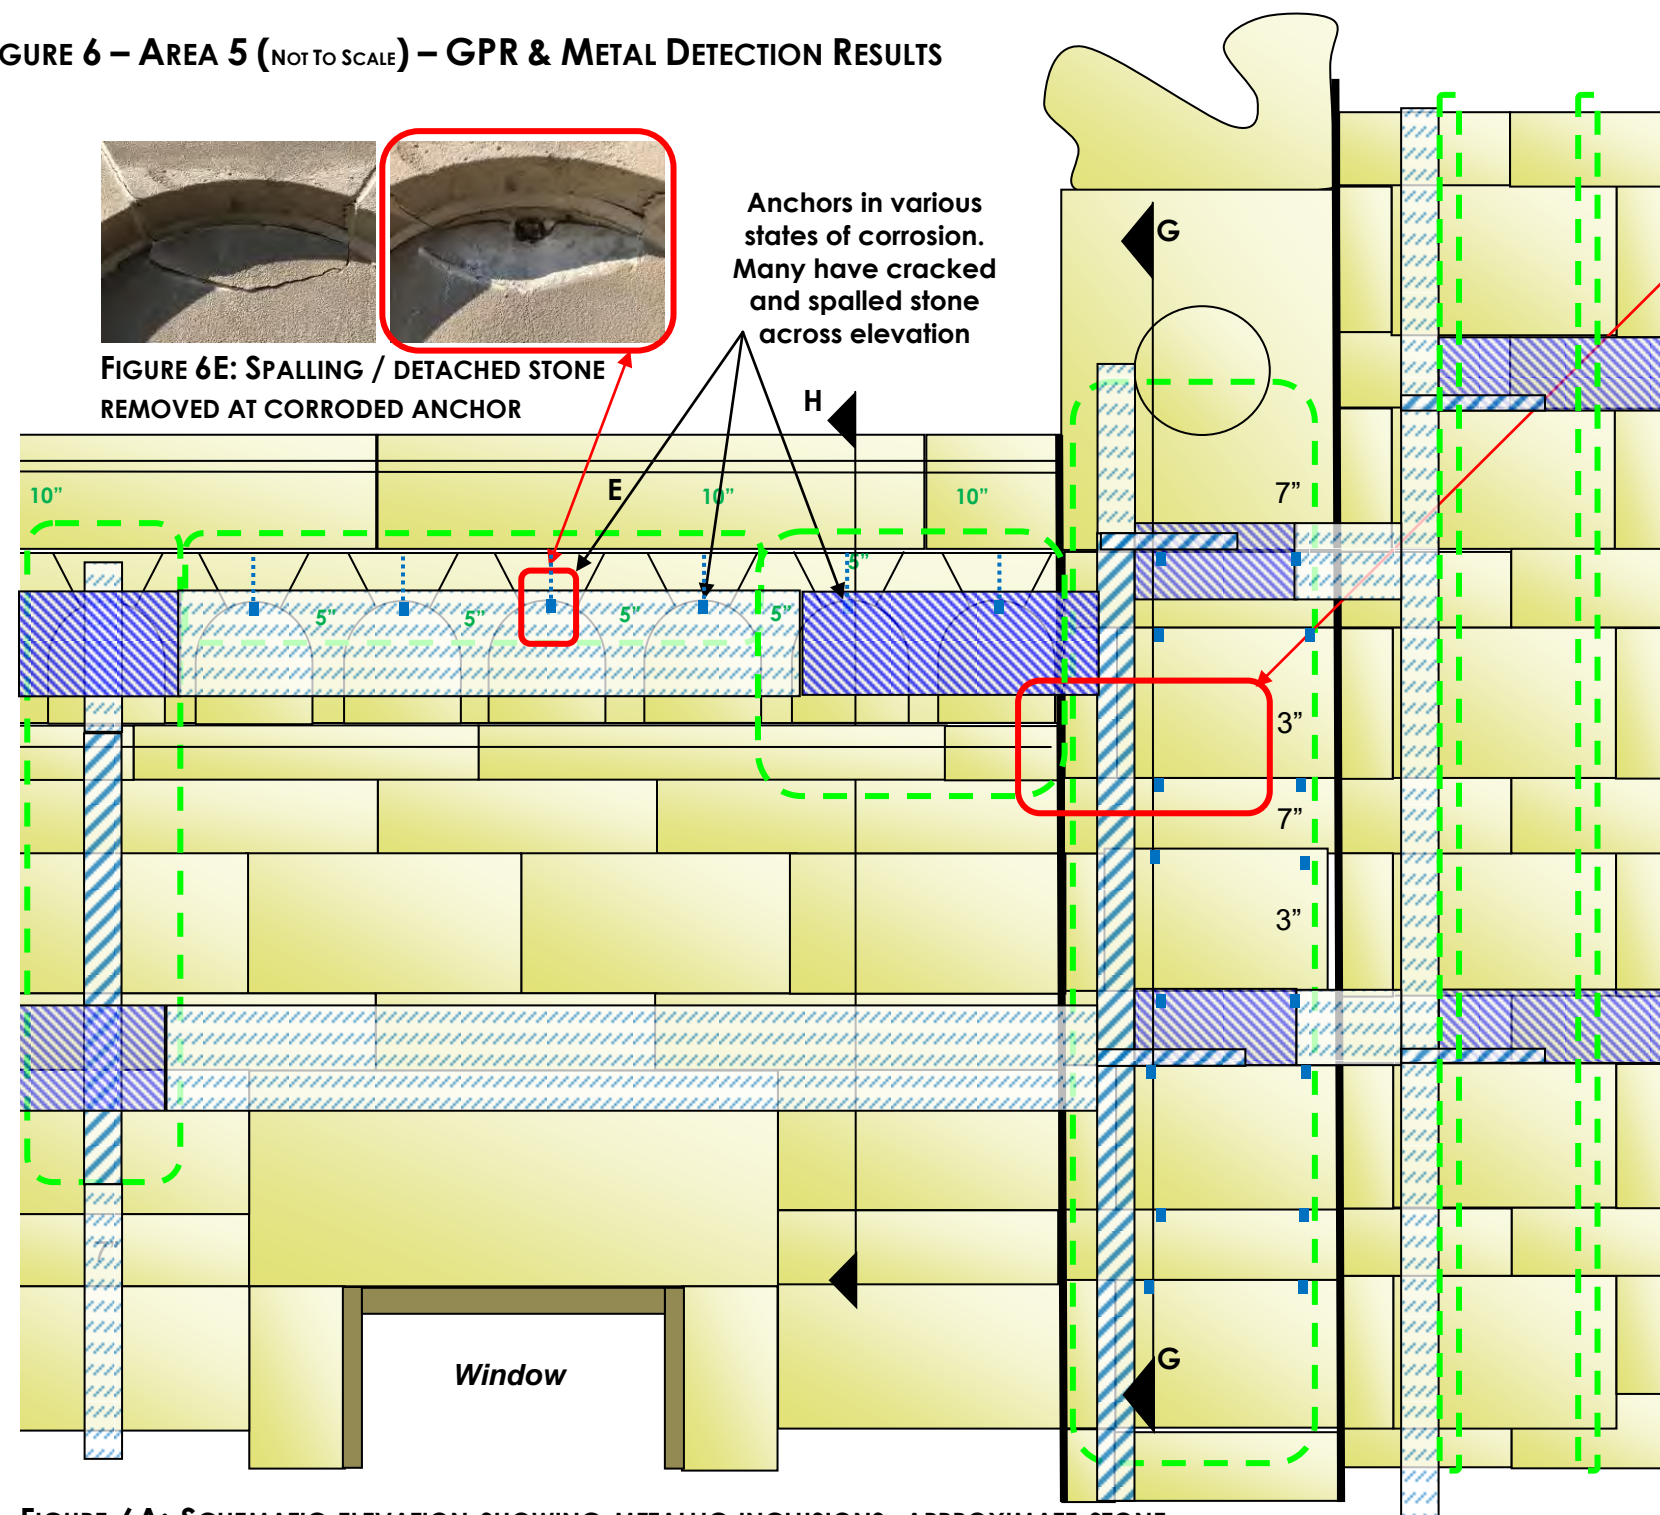
FIGURE 6A: SCHEMATIC ELEVATION SHOWING METALLIC INCLUSIONS, APPROXIMATE STONE BLOCK THICKNESSES AND EVIDENCE OF STEEL FRAMING IDENTIFIED AT AREA 6

Significant open jointing and cracking likely a result of corroding spandrel beam behind stone pier
