ADDENDUM 1
to the
BIDDING DOCUMENTS
for

**Jim Whelan Boardwalk Hall
Boardwalk Façade Renovation – Pilot Project
Atlantic City, MJ**

October 25, 2019

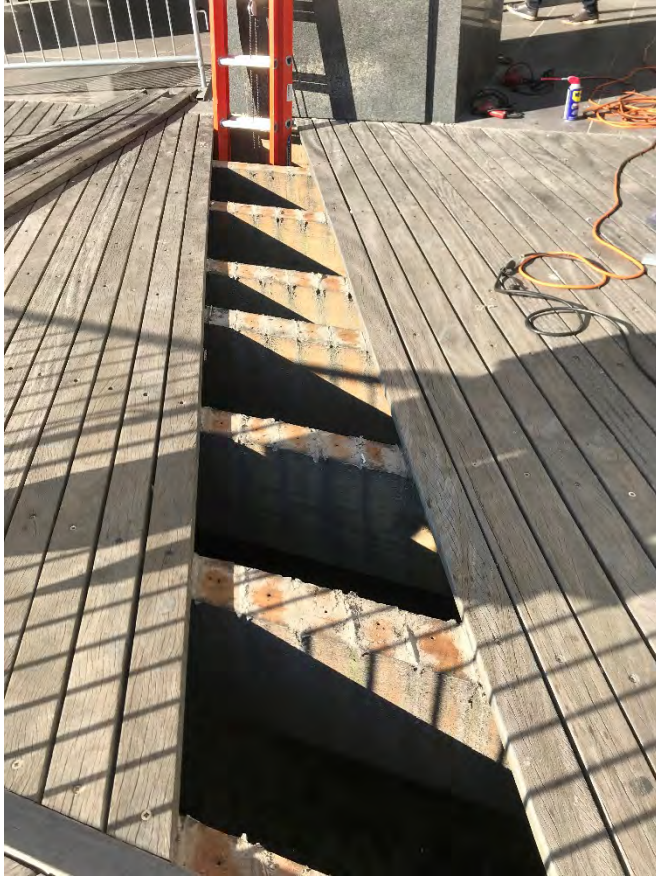
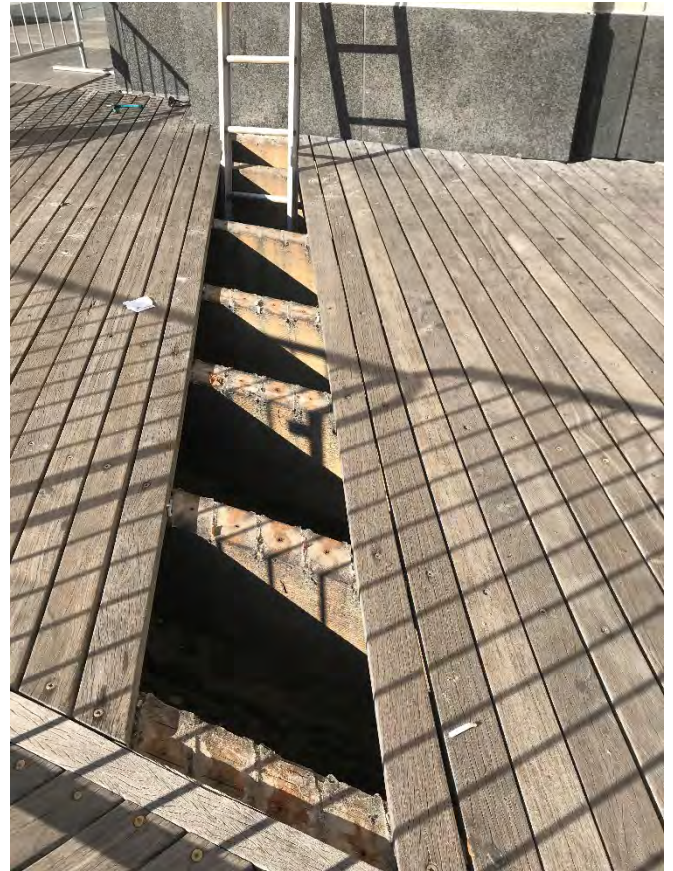
The following pages show our backup calculations demonstrating that the Boardwalk's floor joists appear to have adequate capacity for the 5845-pound outrigger load for the proposed manlift. Although this does not account for all areas of the boardwalk, it is believed to cover those areas visible from the underside during our inspection where we accessed those areas by removing the decking timbers as shown in the following photographs:

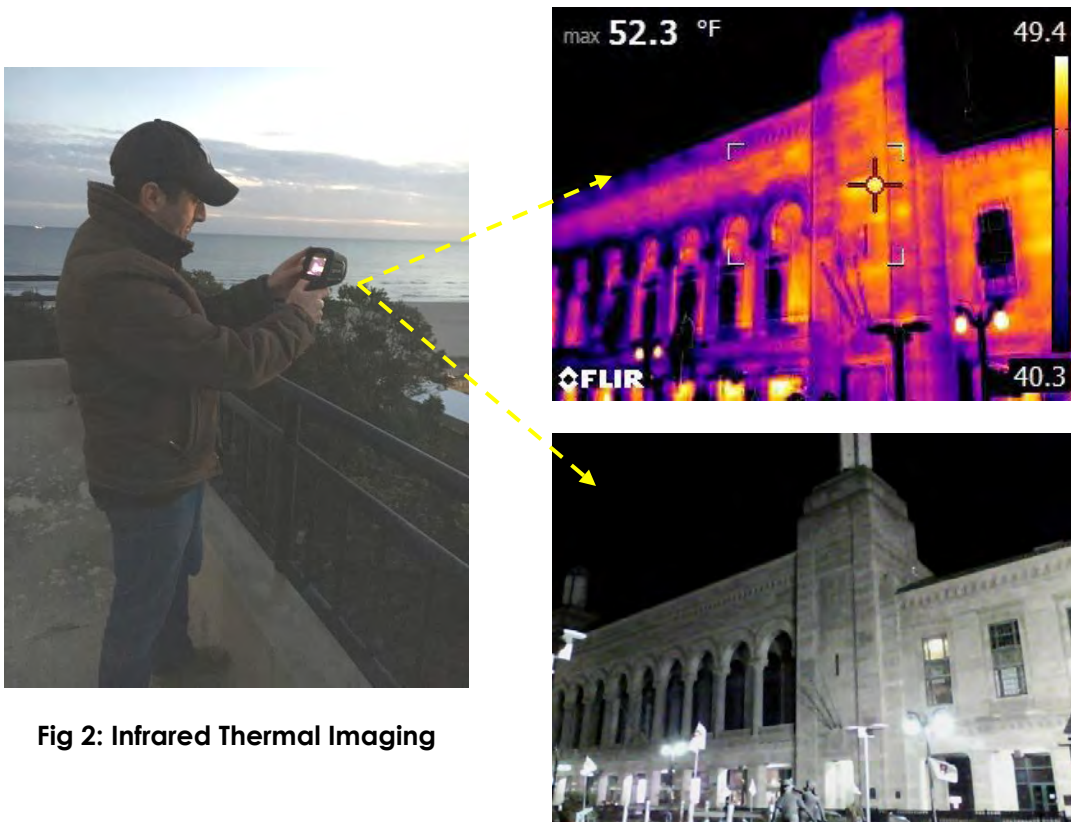
Fig 2: Infrared Thermal Imaging

CBZ CONSULTING utilized IRT to map variations in temperature across the façade that relate to heat transfer through the wall and diurnal surface temperature fluctuations; these variations highlight conditions such as retained moisture, voiding, spalling and masonry thickness variations (See Fig 2 below).

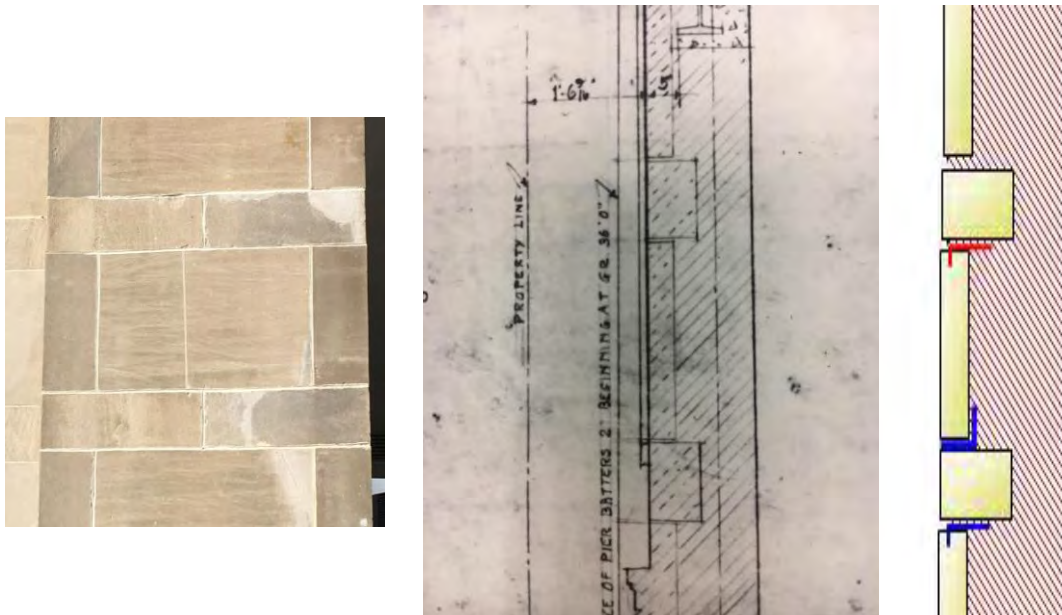
Fig 3: Left: Image showing block coursing / **Middle:** Original drawing section through façade / **Right:** CBZ part section through façade created through NDE data analysis

A cut out from an original drawing section and a cut out of the schematic section created by CBZ (Figure 3, See Also Appendix A) are shown below and highlight how closely the as-built construction resembles the original drawing designs.

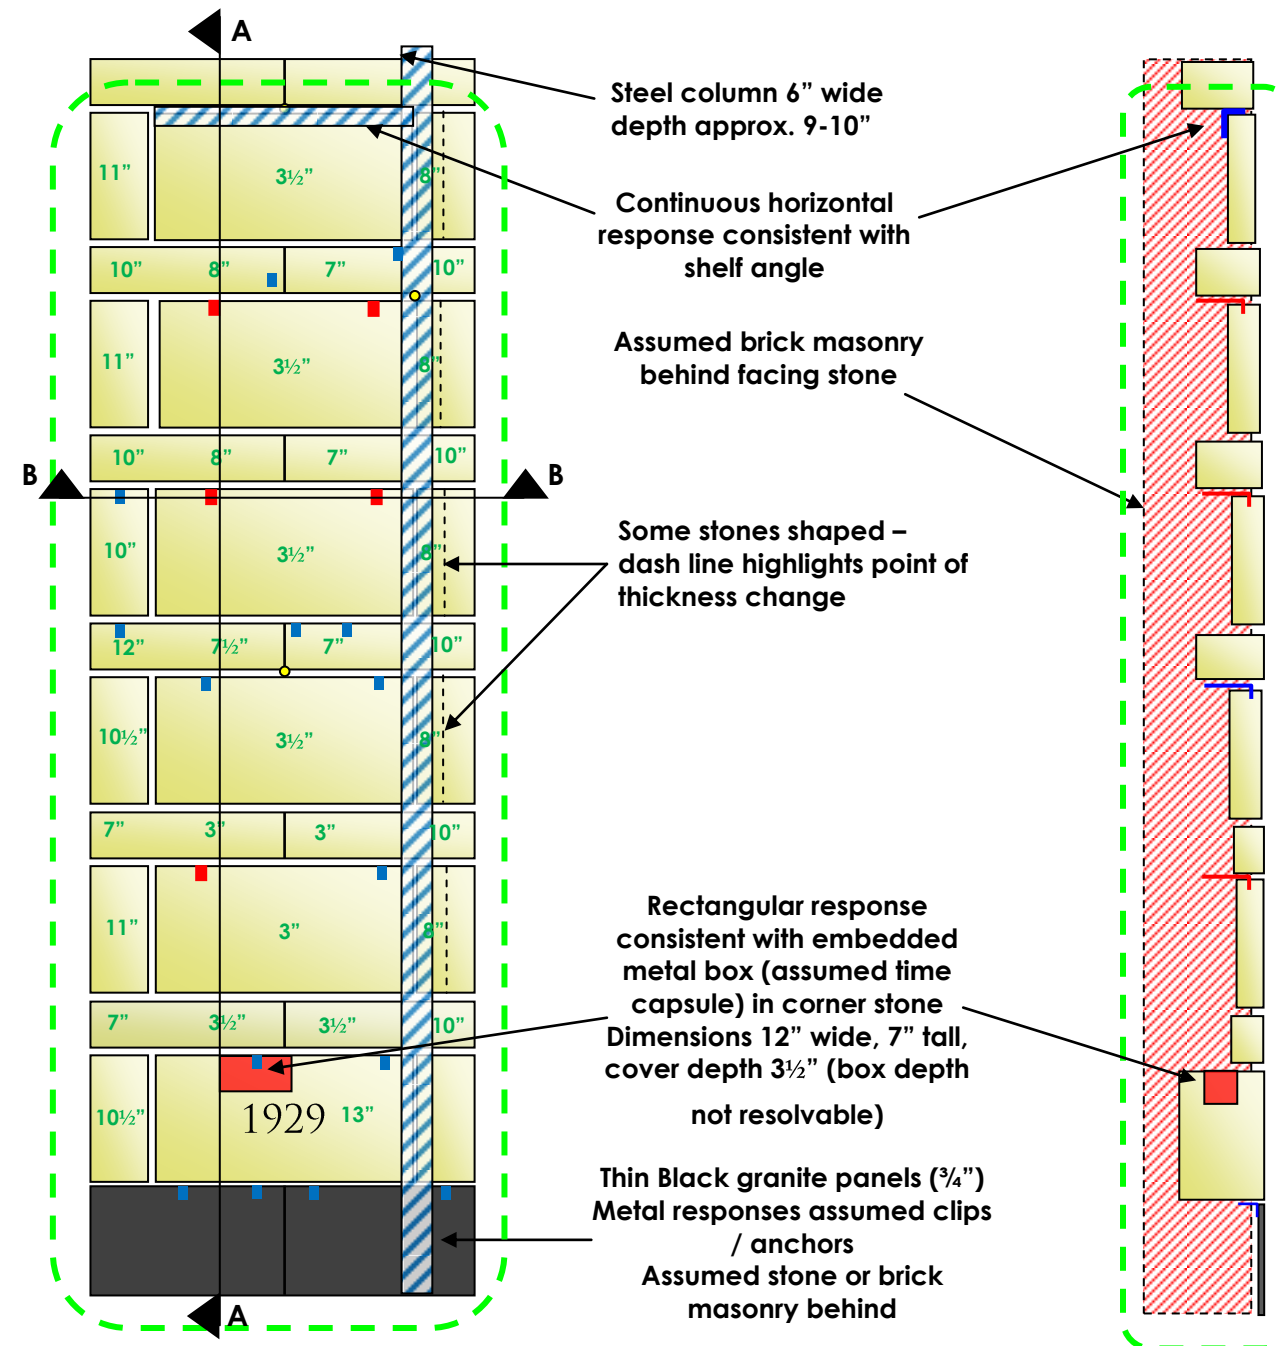
FIGURE 2C: SCHEMATIC ELEVATION SHOWING METALLIC INCLUSIONS (ASSUMED ANCHORS, COLUMN AND ANGLE) AND STONE THICKNESSES

- **Area 1** – Of the sixteen (16) anchors resolved in Area 1 a total of five (5) or 31% appear to be placed <1" from the exterior face. These have been colored red on the Appendix drawings Figure 2A.

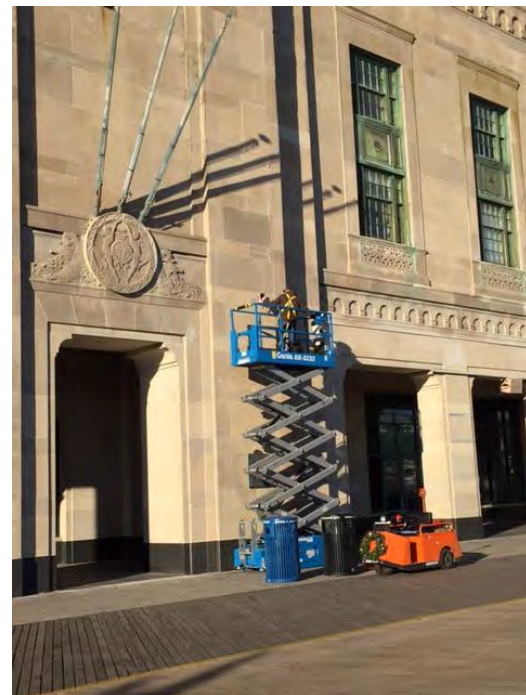
FIGURE 3A: GENERAL VIEW OF AREA 2 UNDER INSPECTION

- **Area 2** – Of the seven (7) anchors resolved in Area 2 a total of three (3) or 42% appear to be placed <1" from the exterior face. These have been colored red on the Appendix drawings Figure 3A.

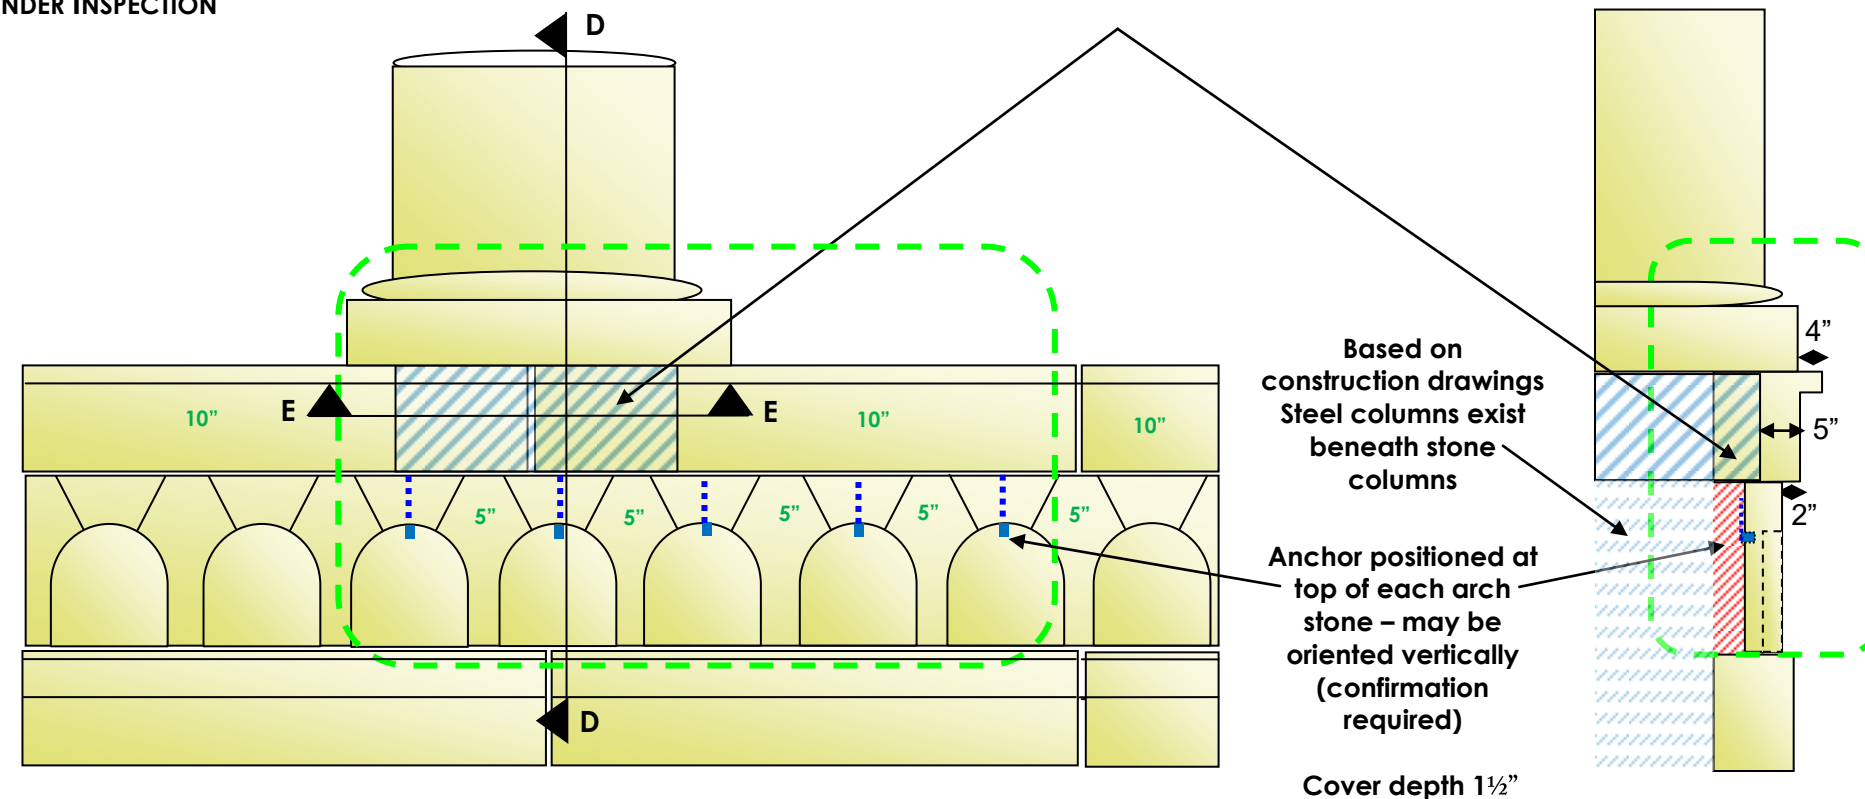
FIGURE 4B: SCHEMATIC ELEVATION SHOWING METALLIC INCLUSIONS (ASSUMED STEEL CONTAINING PLINTH AND DOWELS) AND STONE THICKNESSES

In addition to the corners the stone courses beneath the Boardwalk façade loggia columns are also cracking and displaced (pushing out / bulging) as a result of corrosion to embedded steel behind, the extent of which will need to be established through future probing and visual inspection (See Appendix Figure 4 for more information).

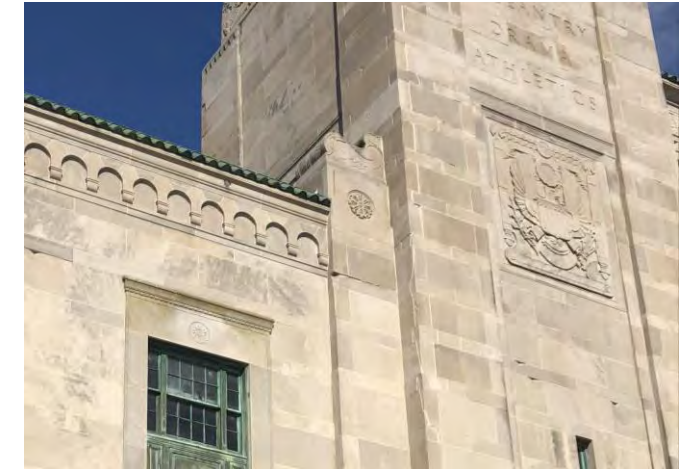
FIGURE 6D: IMAGES SHOWING AREA 6

Smaller areas of localized spalling are actively occurring as a result of embedded corroding steel anchors. Although only a relatively small number of these spalls are currently visible from street level and only a small number have actually failed and fallen, close up inspections by CBZ has revealed numerous hairline cracks, rust stains and early stage spalls, which will continue to worsen and detach from the façade during cold weather conditions as a result of freeze thaw cycles. One spall during Visit 2 was actually removed from the façade by CBZ as it was loose and represented a health and safety risk to pedestrians below (See images in Appendix Figure 6).

Significant open jointing and cracking likely a result of corroding spandrel beam behind stone pier

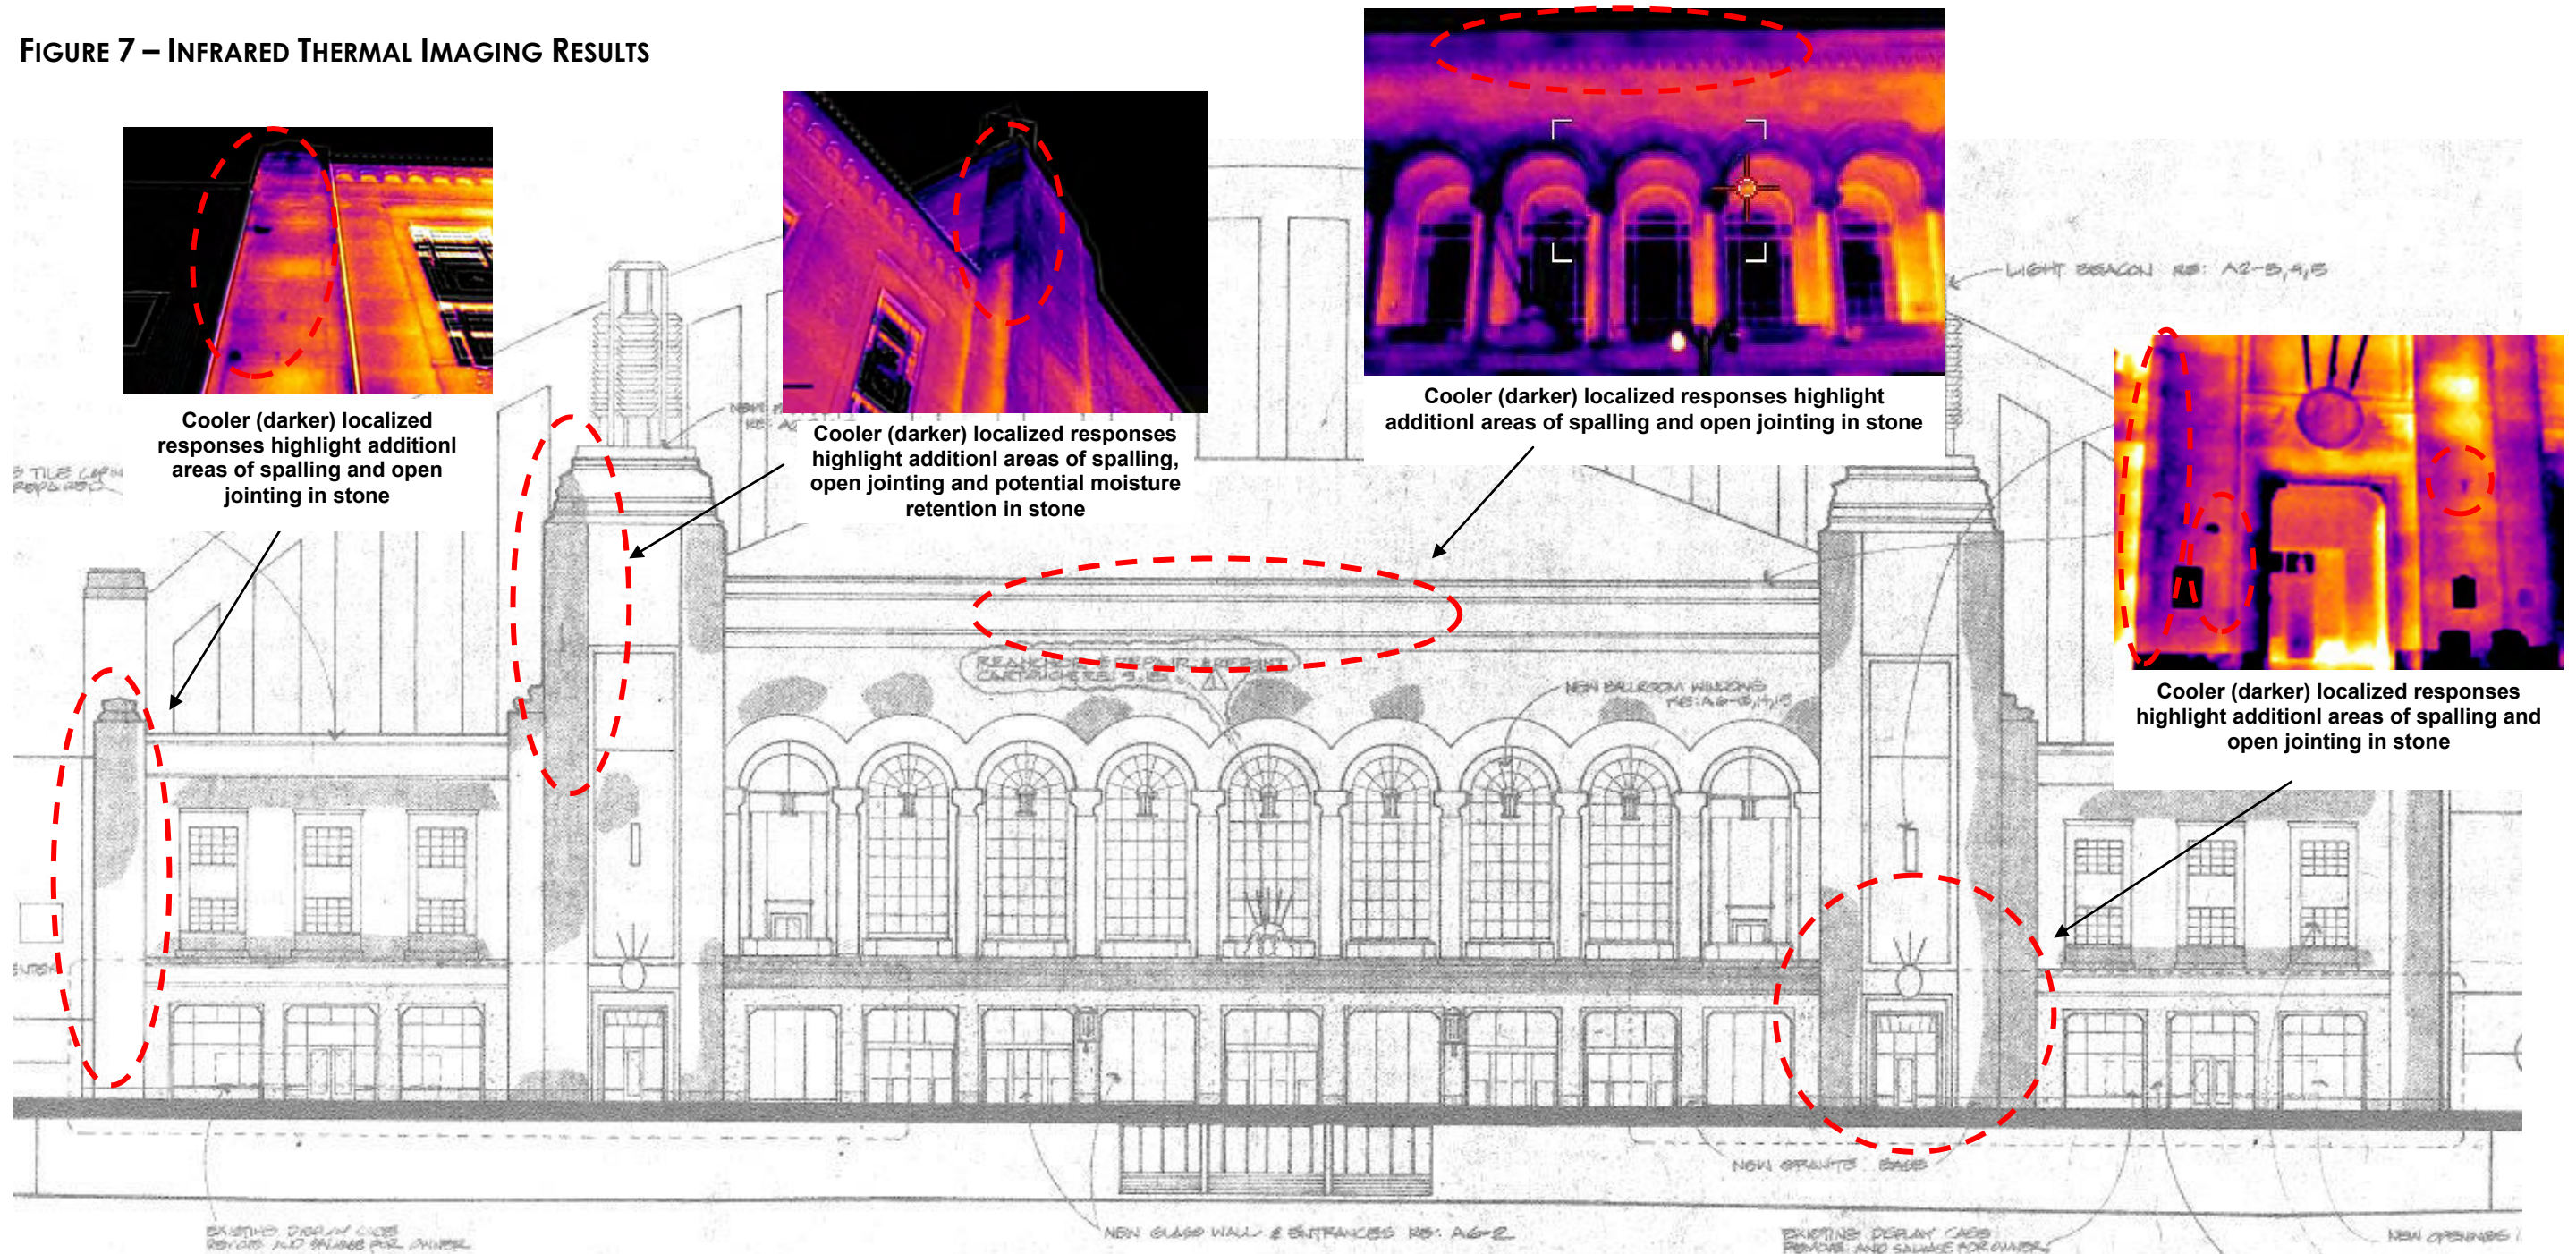
FIGURE 7A: BOARDWALK ELEVATION

Infrared thermal imaging was conducted from street level and from an adjacent roof top at trump Plaza. The review highlighted a number of results which are explained in more detail below. The thermal imaging results are presented in the Appendix, as Figure 7. A description of the thermal imaging analysis procedures and what types of conditions are resolvable in the data collected is provided below.

Although thermal imaging results are presented as Figure 7 in the Appendix, the results are generalized and highlight that the problem of open jointing and spalling stone extends well beyond the targeted five (5) areas investigated using GPR and Metal detection.
